## **REPORT ON GEOTECHNICAL INVESTIGATION AND SLOPE STABILITY**

Proposed Subdivisional Development

248 Woolmer Road, Highfields QLD 4352

SGT230004-R1

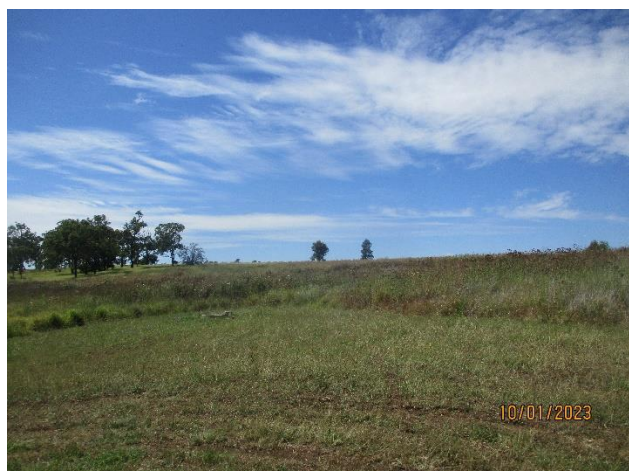
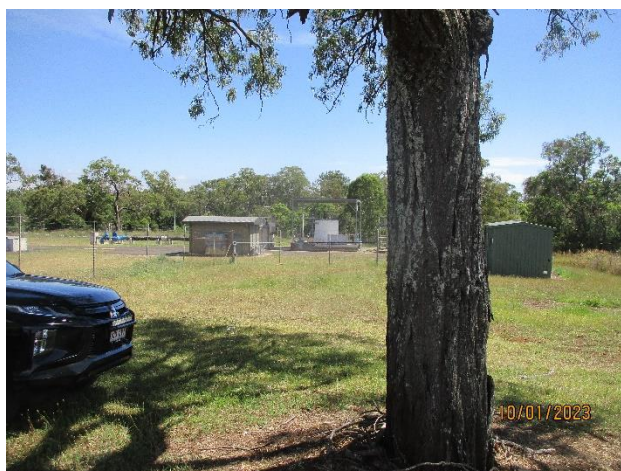
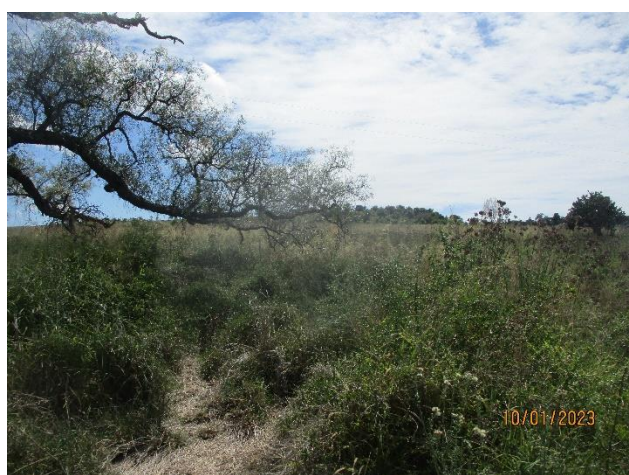
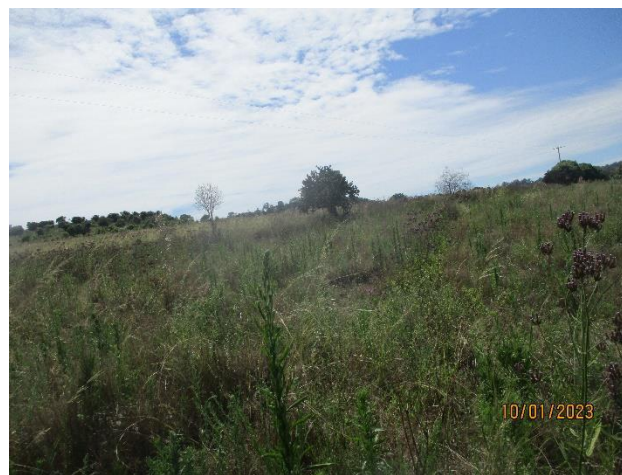
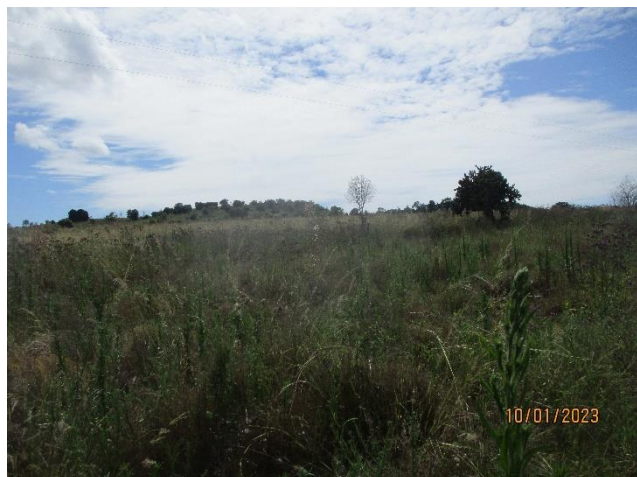
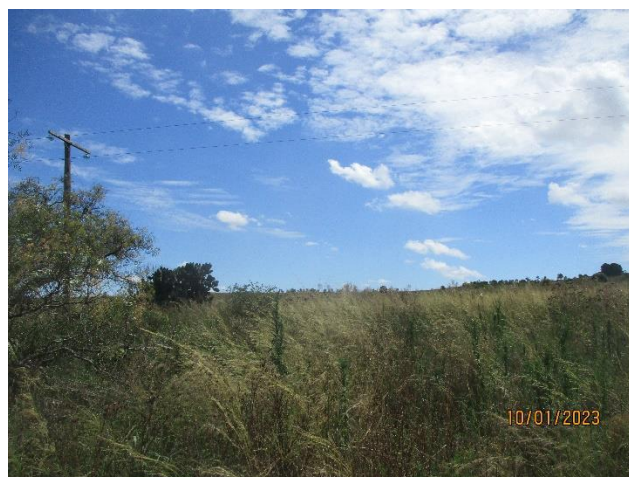
A site inspection was carried out by SGT on 10 January 2023. Access to the site was limited during the site inspection due to dense vegetation. Based on the site inspection, there are no indication of unstable condition within the site, evidence of up to 12<sup>0</sup> slope geometry and moderate to dense vegetation were observed during the site inspection. Site photographs were taken by ASCT are presented below.

**Figures 1 - 6:** Typical Site Conditions During the Geotechnical Investigation.

Based on a flat to gentle sloping geometry (less than 1V:4H slope within the site), it is our opinion that the proposed subdivisional development will not be subject to landslip or subsidence or slope instability issues.
